Decreased Cooling In GM And VW Cars And Trucks Could Mean A Faulty Refrigerant Control Valve, Not A Failed Compressor

By **Ignacio (Nacho) Corella**

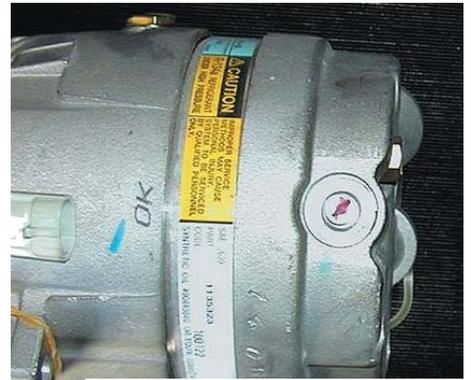
In GM products with the V5 and V7 compressors, the RCV is located in the rear cover of the compressor, and looks like a nipple on the outside (Photo 1). It's held in place by a snap ring and looks like spinning top (Photo 2). In most or all

Photo 1. Locating the RCV on a GM V5 compressor

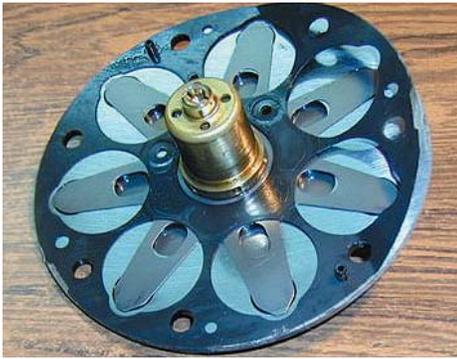
Remove the rear cover carefully. It's held in place by 7 bolts. Avoid damaging the gaskets between the cover and the compressor's body (Photo 2A). Once the cover is off, the reed valve plate will come off. Installed in it, you'll see the RCV (Photos 3, 4, and 5).

Photo 2A. SD7V16 gasket top view

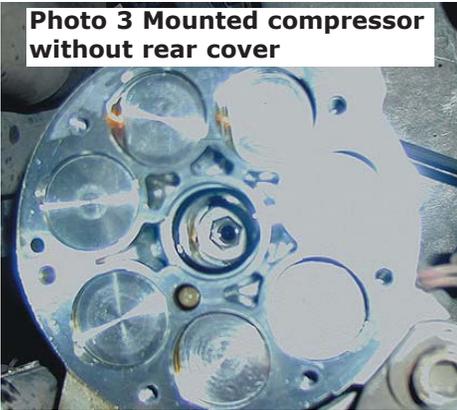
Photo 3 Mounted compressor without rear cover

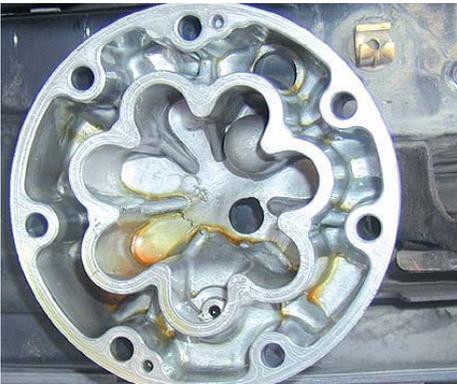
Right: Photo 4 Rear compressor cover internal view

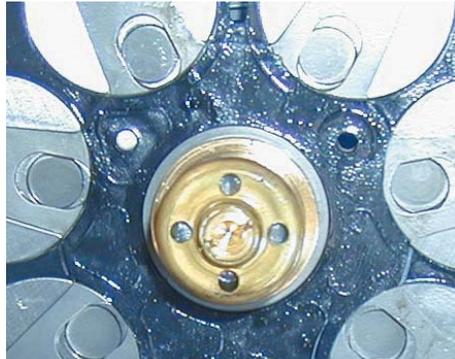
Photo 5. Closeup of RCV installed in compressor

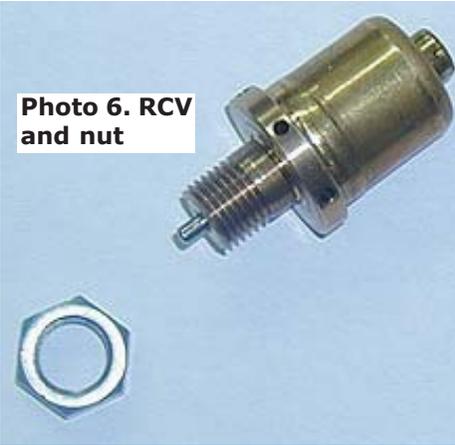
The valve is held in place by a 7/16" nut in the opposite side. Remove the nut (Photo 6), remove the valve, replace it, and re-install the gear plate and cover. Pull a vacuum and charge to specs.

Photo 6. RCV and nut

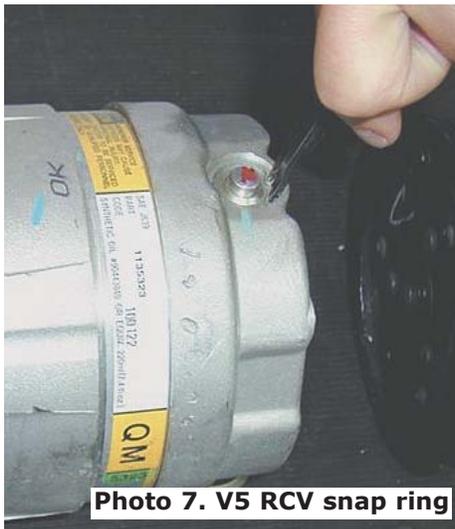
The procedure in both cases is simple. For the V5/V7 compressor, you have to remove the RCV's as shown. (Photos 7, 8, & 9). Now, with a tailored top (it can be aluminum or steel, or even alu-

Photo 7. V5 RCV snap ring

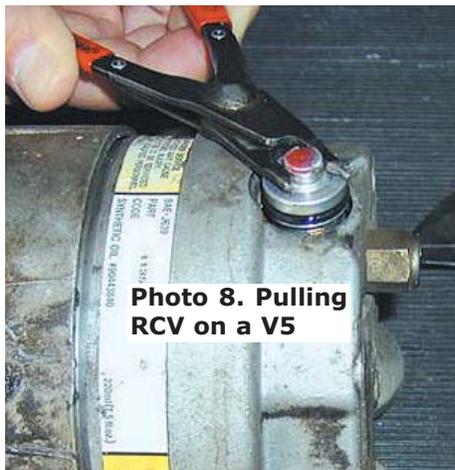
Photo 8. Pulling RCV on a V5

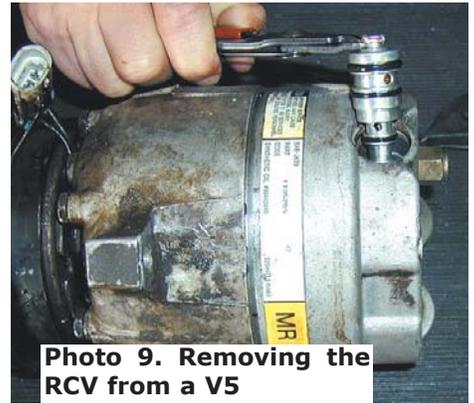
Photo 9. Removing the RCV from a V5

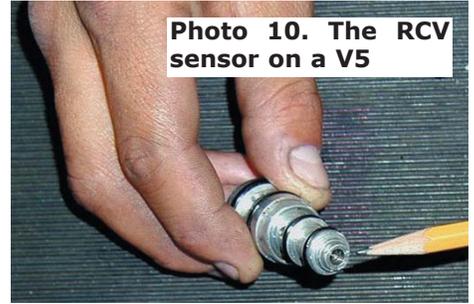
minum brazing), seal the orifice. Make sure the top is secured by pressing it into the receptacle. (Photos 10 & 11)

Photo 10. The RCV sensor on a V5

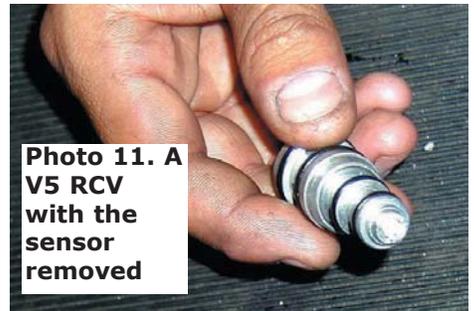
Photo 11. A V5 RCV with the sensor removed

Re-install the valve in the compressor and secure it with the snap ring.

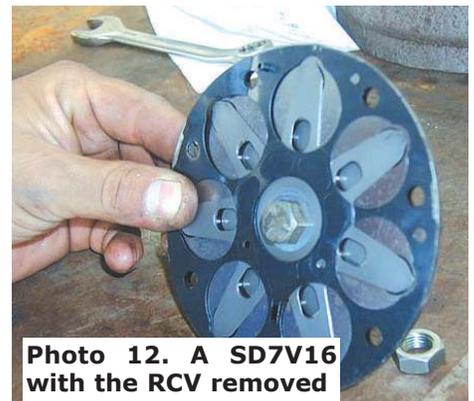
Photo 12. A SD7V16 with the RCV removed

sor, the RCV is simply replaced by a 7/16" X 1" bolt and nut as shown (picture 12).

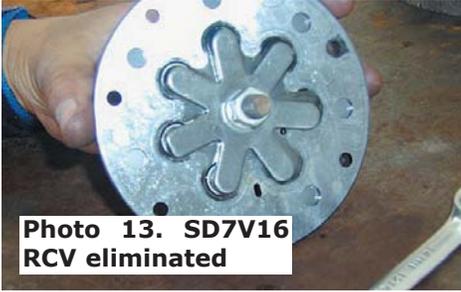
**Photo 13. SD7V16
RCV eliminated**

In the case of the SD7V16, don't be surprised by a noticeable suction pressure drop below 15 at once. Given the compressor's design, it is normal.

Like in the GM compressors, a clutch cutoff method must be provided to avoid evaporator freezing. \$\$\$
